The fire resistance performance of two single-acting, single-leaf doorsets incorporating various items of hardware tested in accordance with BS EN 1634-1:2014

345074/A Issue 2

Firestop Manufacturing Limited,
4 Wyvern Buildings,
Grove Trading Estate,
Dorchester,
Dorset,
DT1 1ST.

Date: 21st April 2016

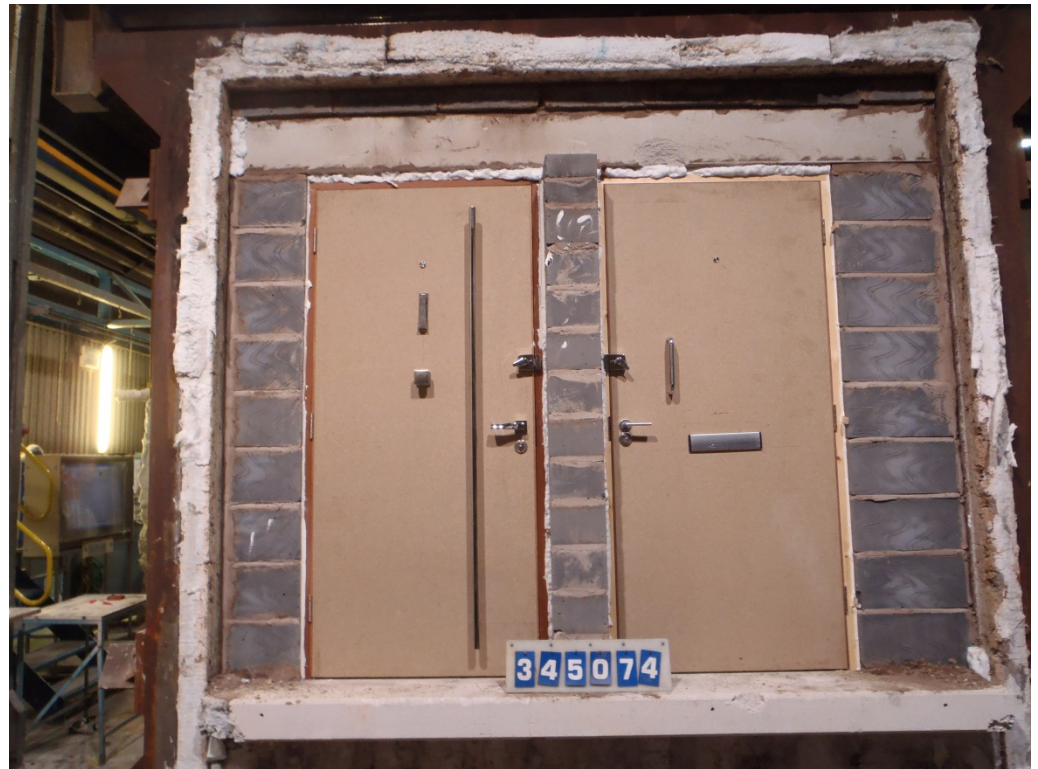
The exposed face of the doorsets prior to testing

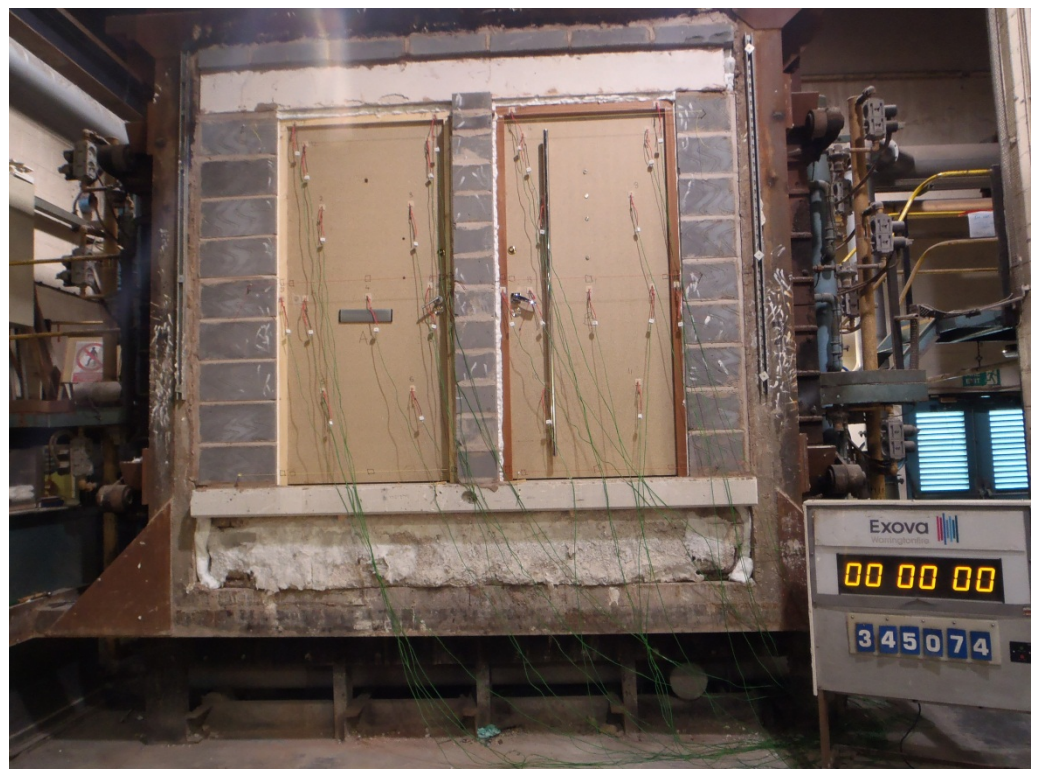
The unexposed face of the doorsets prior to testing

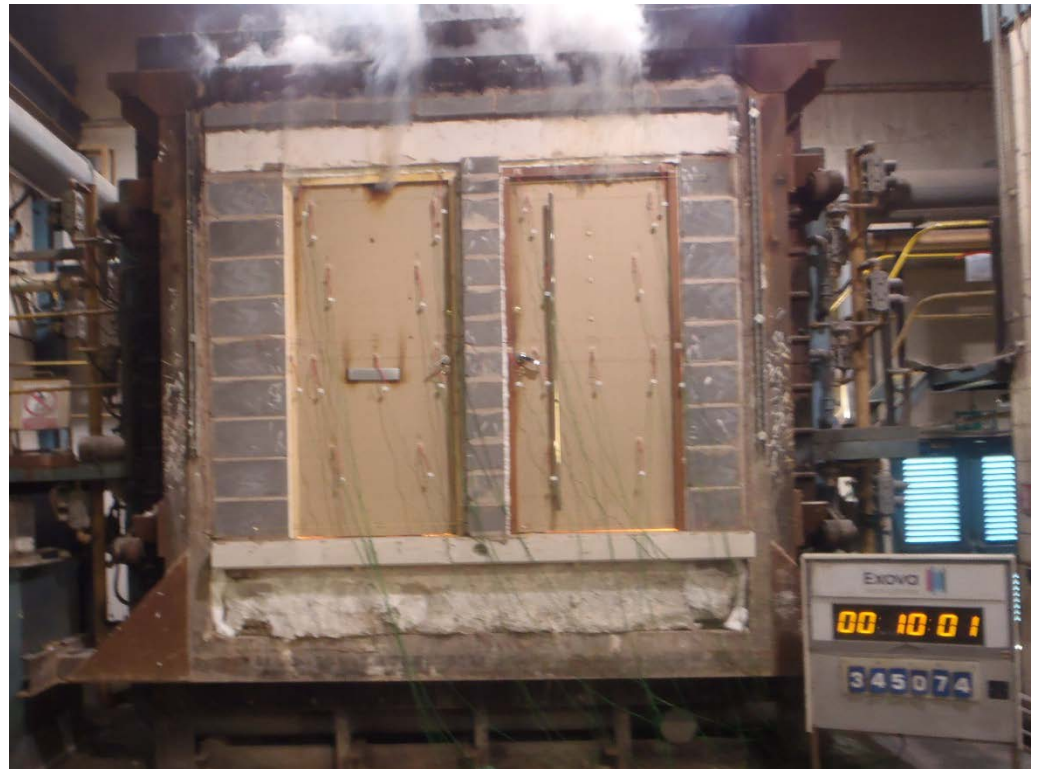
The unexposed face of the doorsets after 10 minutes of testing

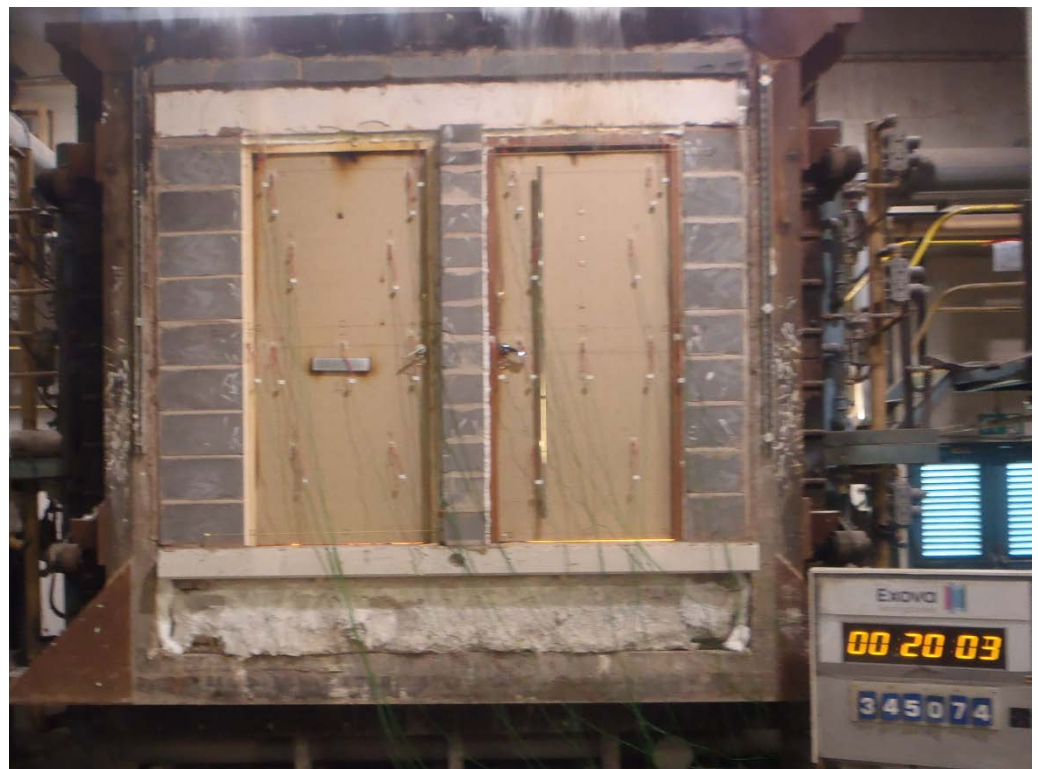
The unexposed face of the doorsets after 20 minutes of testing

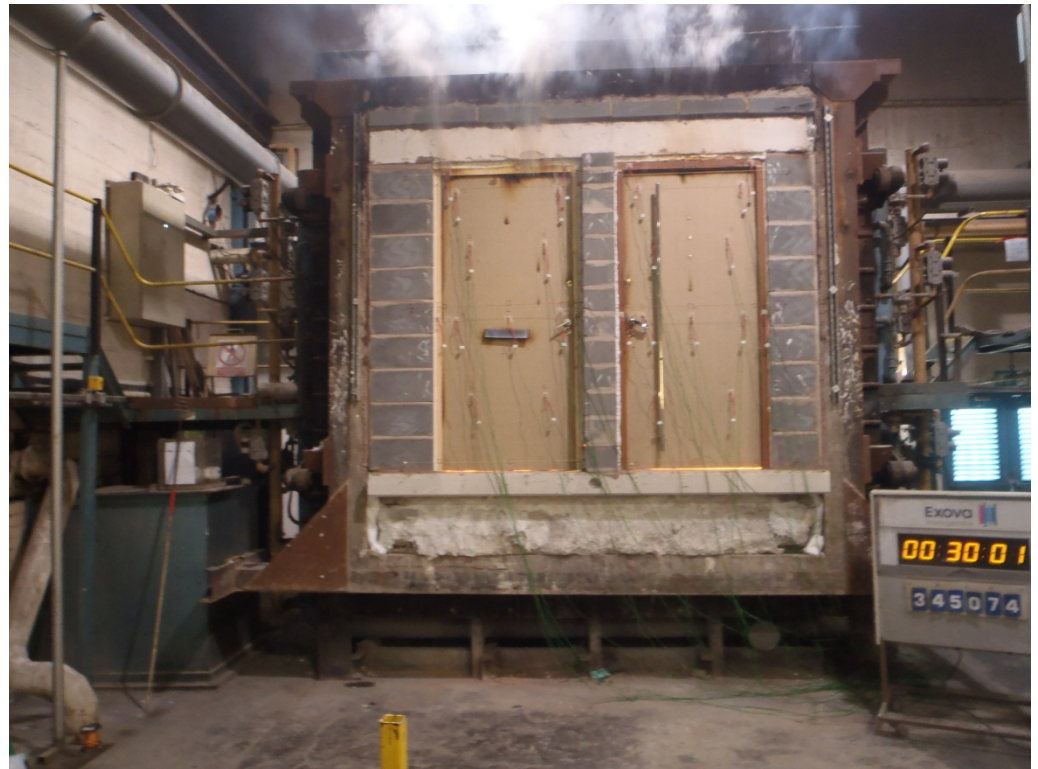
The unexposed face of the doorsets after 30 minutes of testing

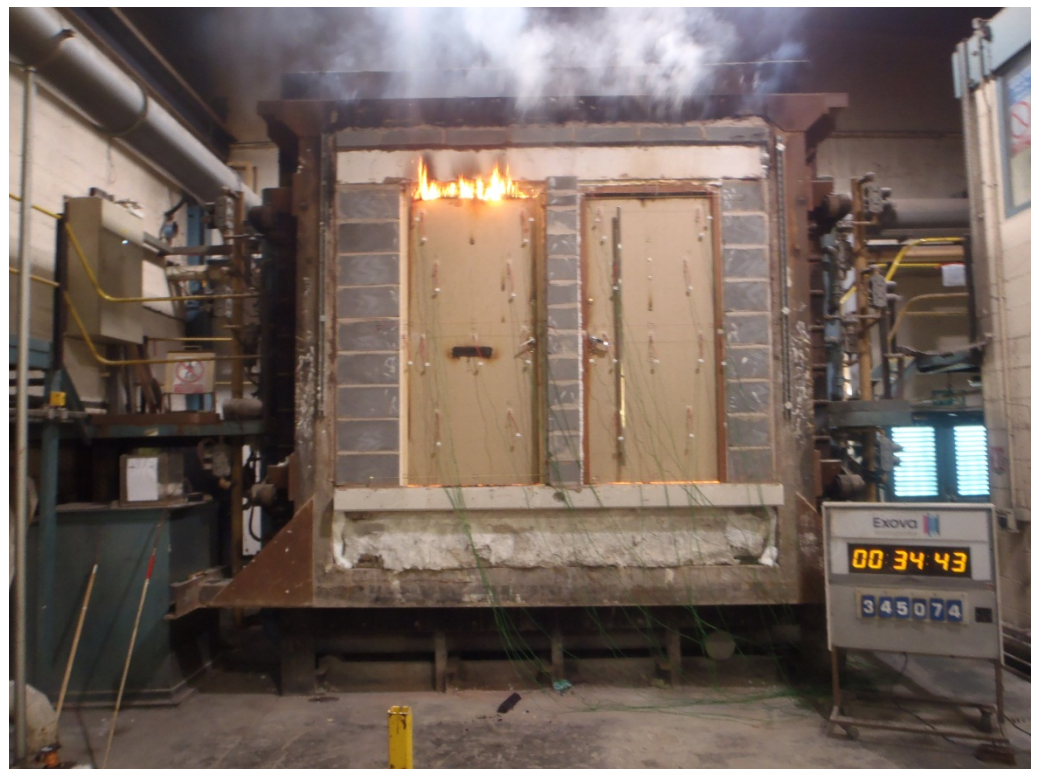
The unexposed face of the doorsets after 34 minutes of testing as sustained flaming formed at the head of Doorset A

Doorset A - All of the hardware on Doorset "A" had achieved in excess of 30 minutes without causing integrity failure.

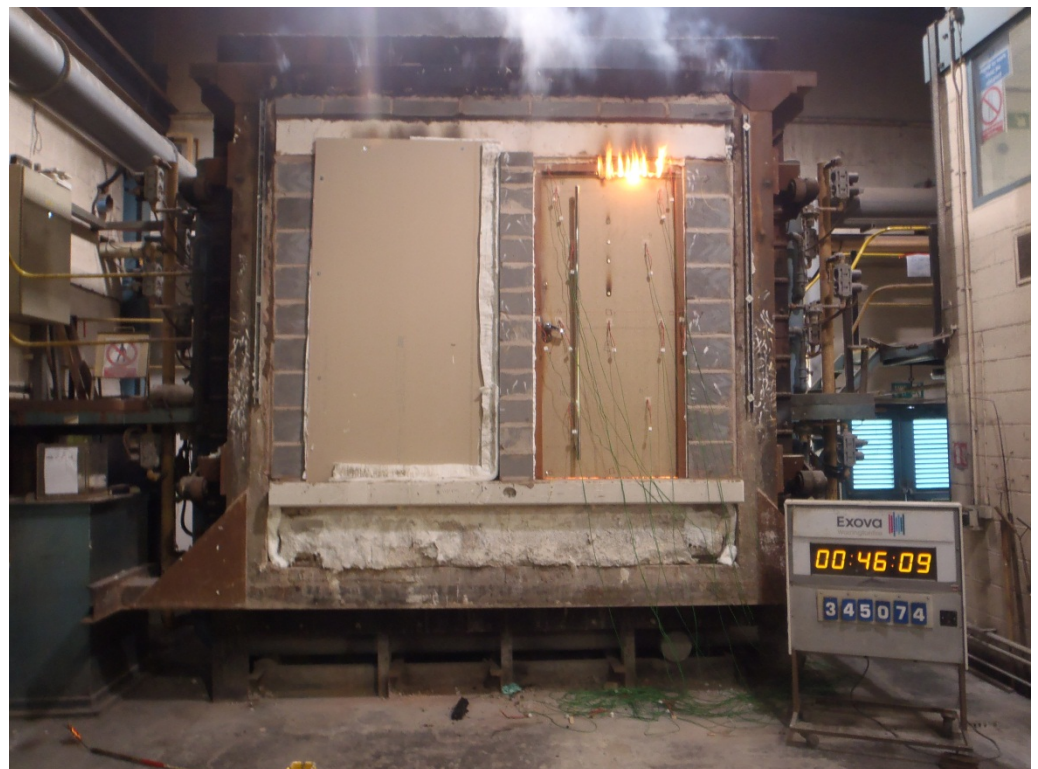
The unexposed face of the doorsets after 46 minutes of testing as sustained flaming formed at the head of Doorset B

Doorset B - Apart from the item of hardware referenced 'DCC2025CF/36', the hardware was not responsible for the integrity failure of the doorset, All other remaining hardware on Doorset "B" achieved in excess of 50 minutes without causing integrity failure

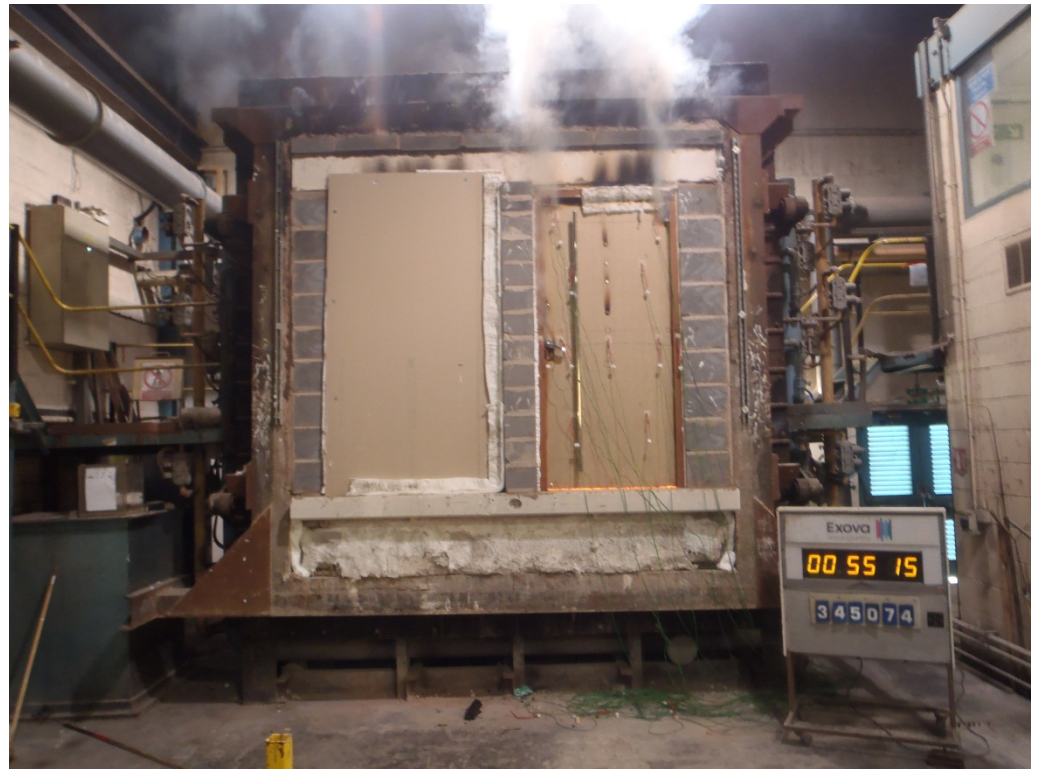
The unexposed face of the doorsets after 55 minutes of testing

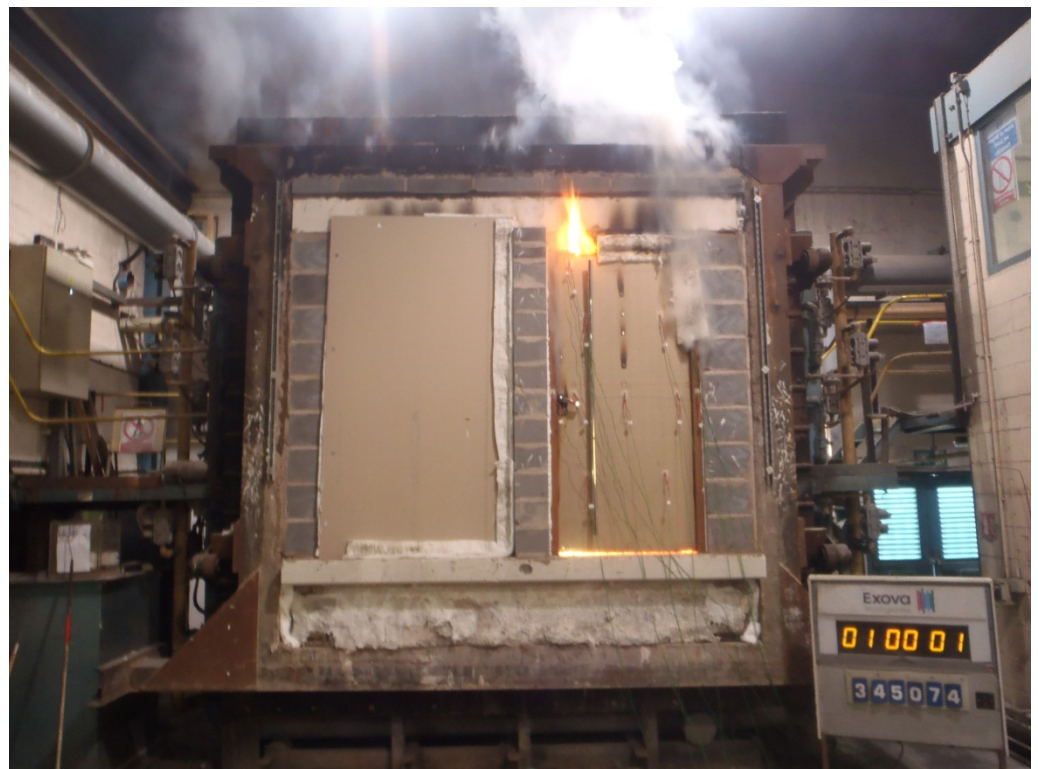
The unexposed face of the doorsets after 60 minutes of testing after which time the test was discontinued

* The test duration. The test was discontinued after a period of 60 minutes.

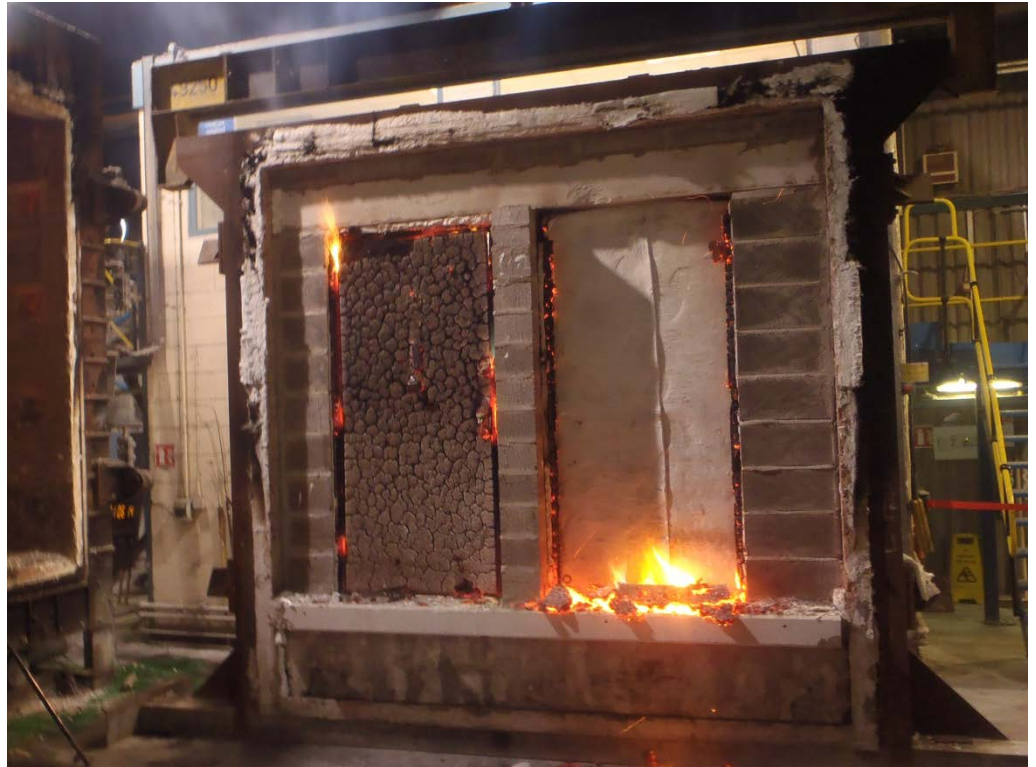
The exposed face
of the test
construction
immediately after
the test

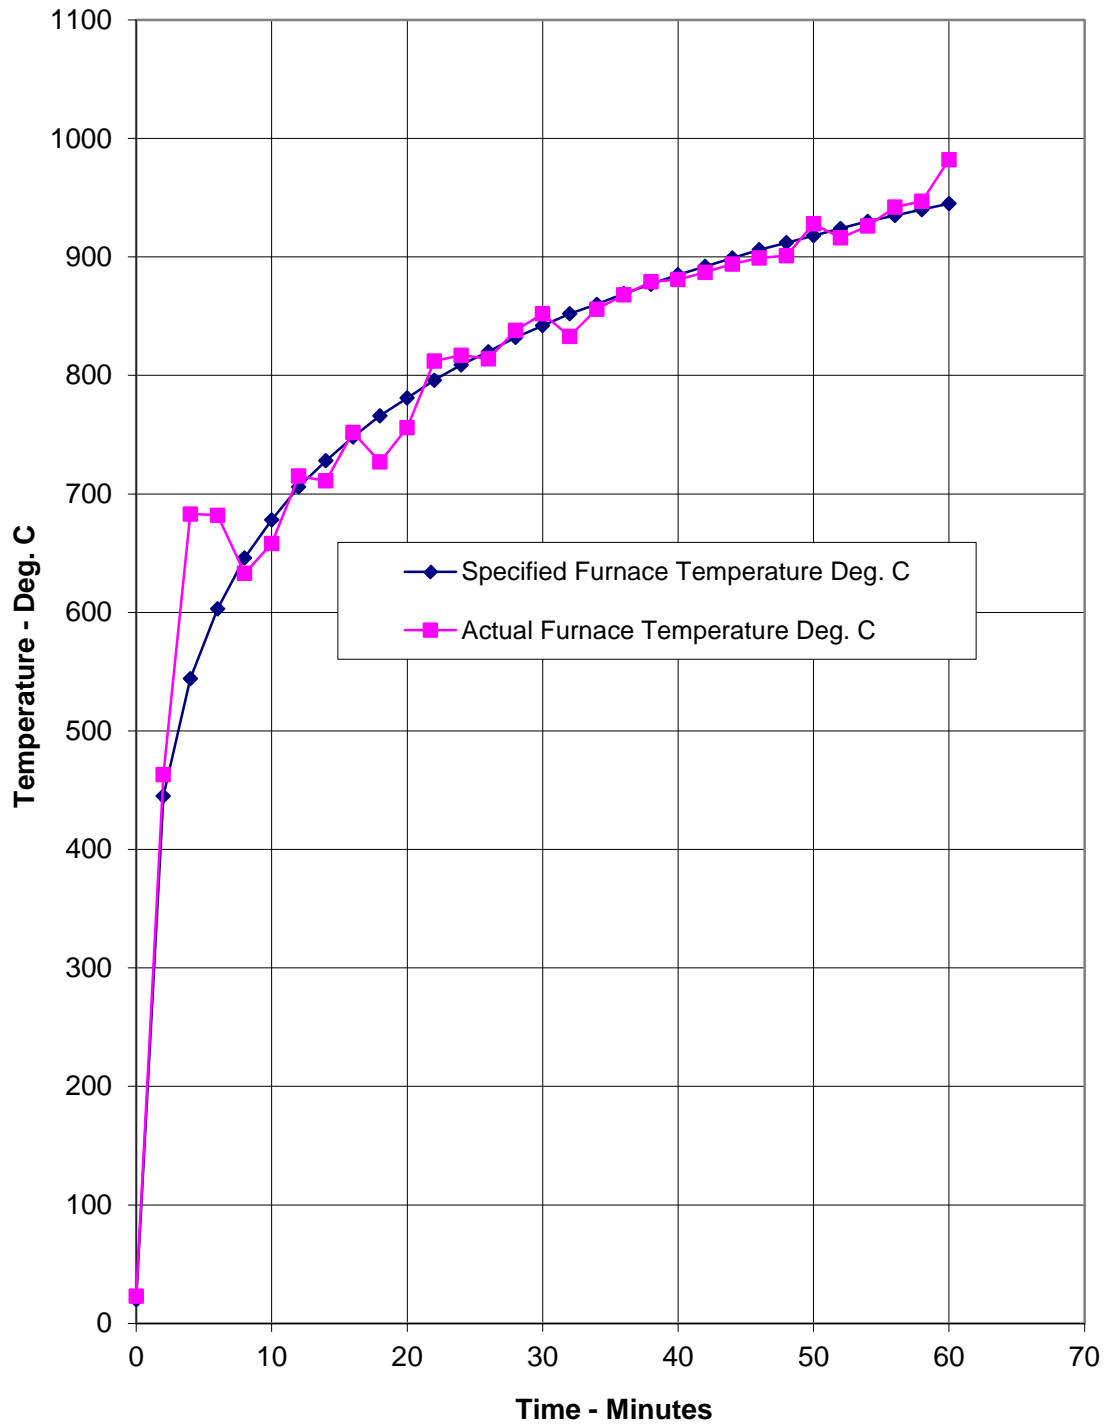
Graph showing mean furnace temperature, together with the temperature/time relationship specified in the Standard
